RCRA Facility Investigation (RFI) Phase I Report

**Waste Management of Ohio, Inc.
Vickery, Ohio**

U.S. EPA ID No. OHD 020 273 819

October 1999

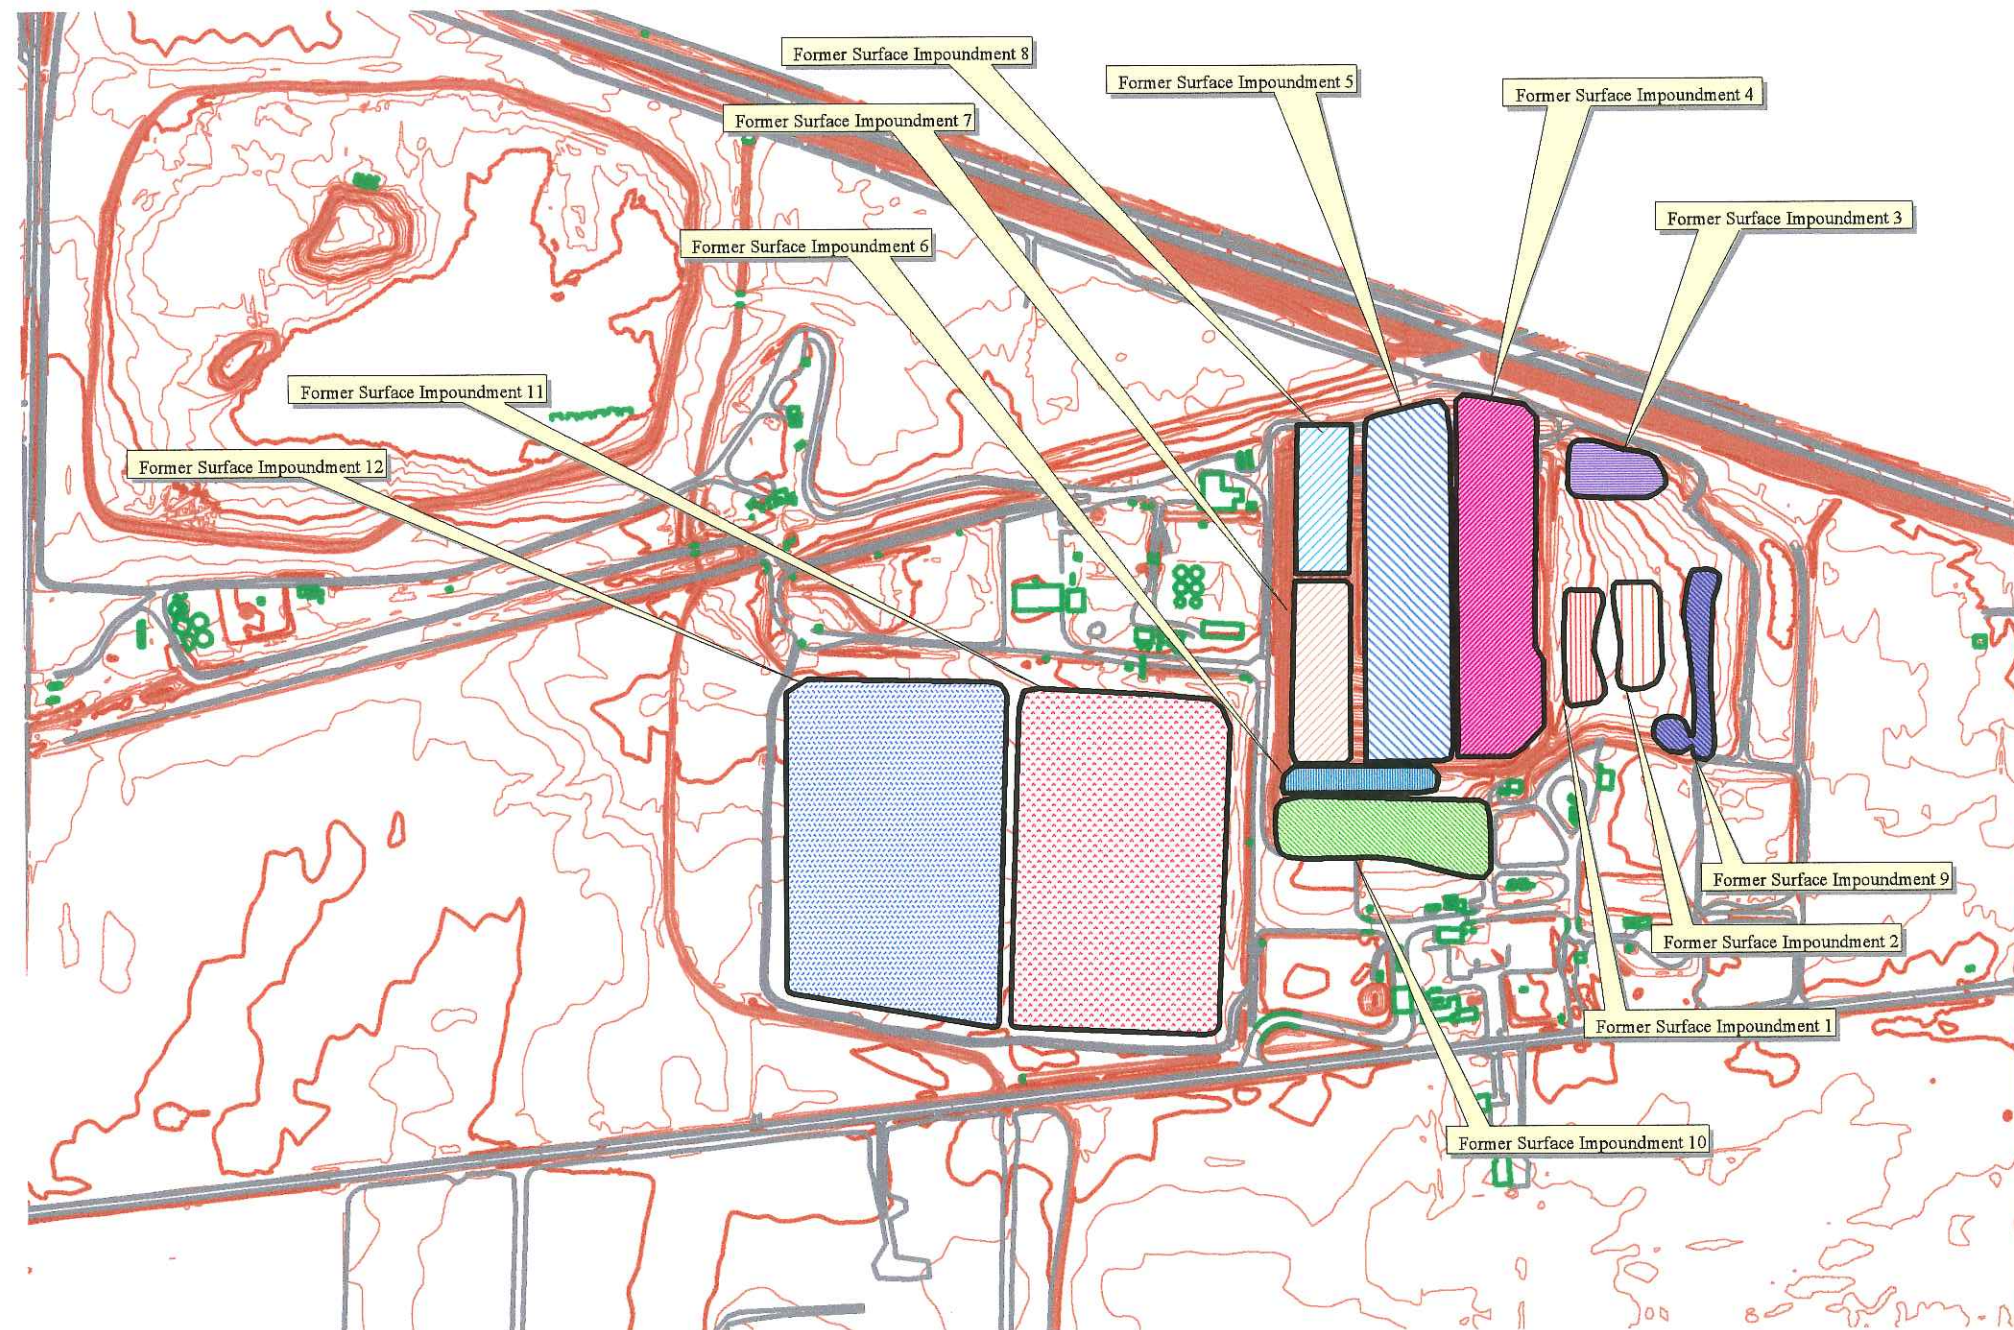
Figure 1-2
Former Surface Impoundment Locations
Waste Management of Ohio - Vickery

During the history of the facility, a total of 12 surface impoundments existed. The locations of these former surface impoundments are shown in Figure 1-2. The surface impoundments were constructed between 1964 and 1975. The surface impoundments were closed between 1979 and 1992; details of these closures can be found in Section 6.0 of the RCC.

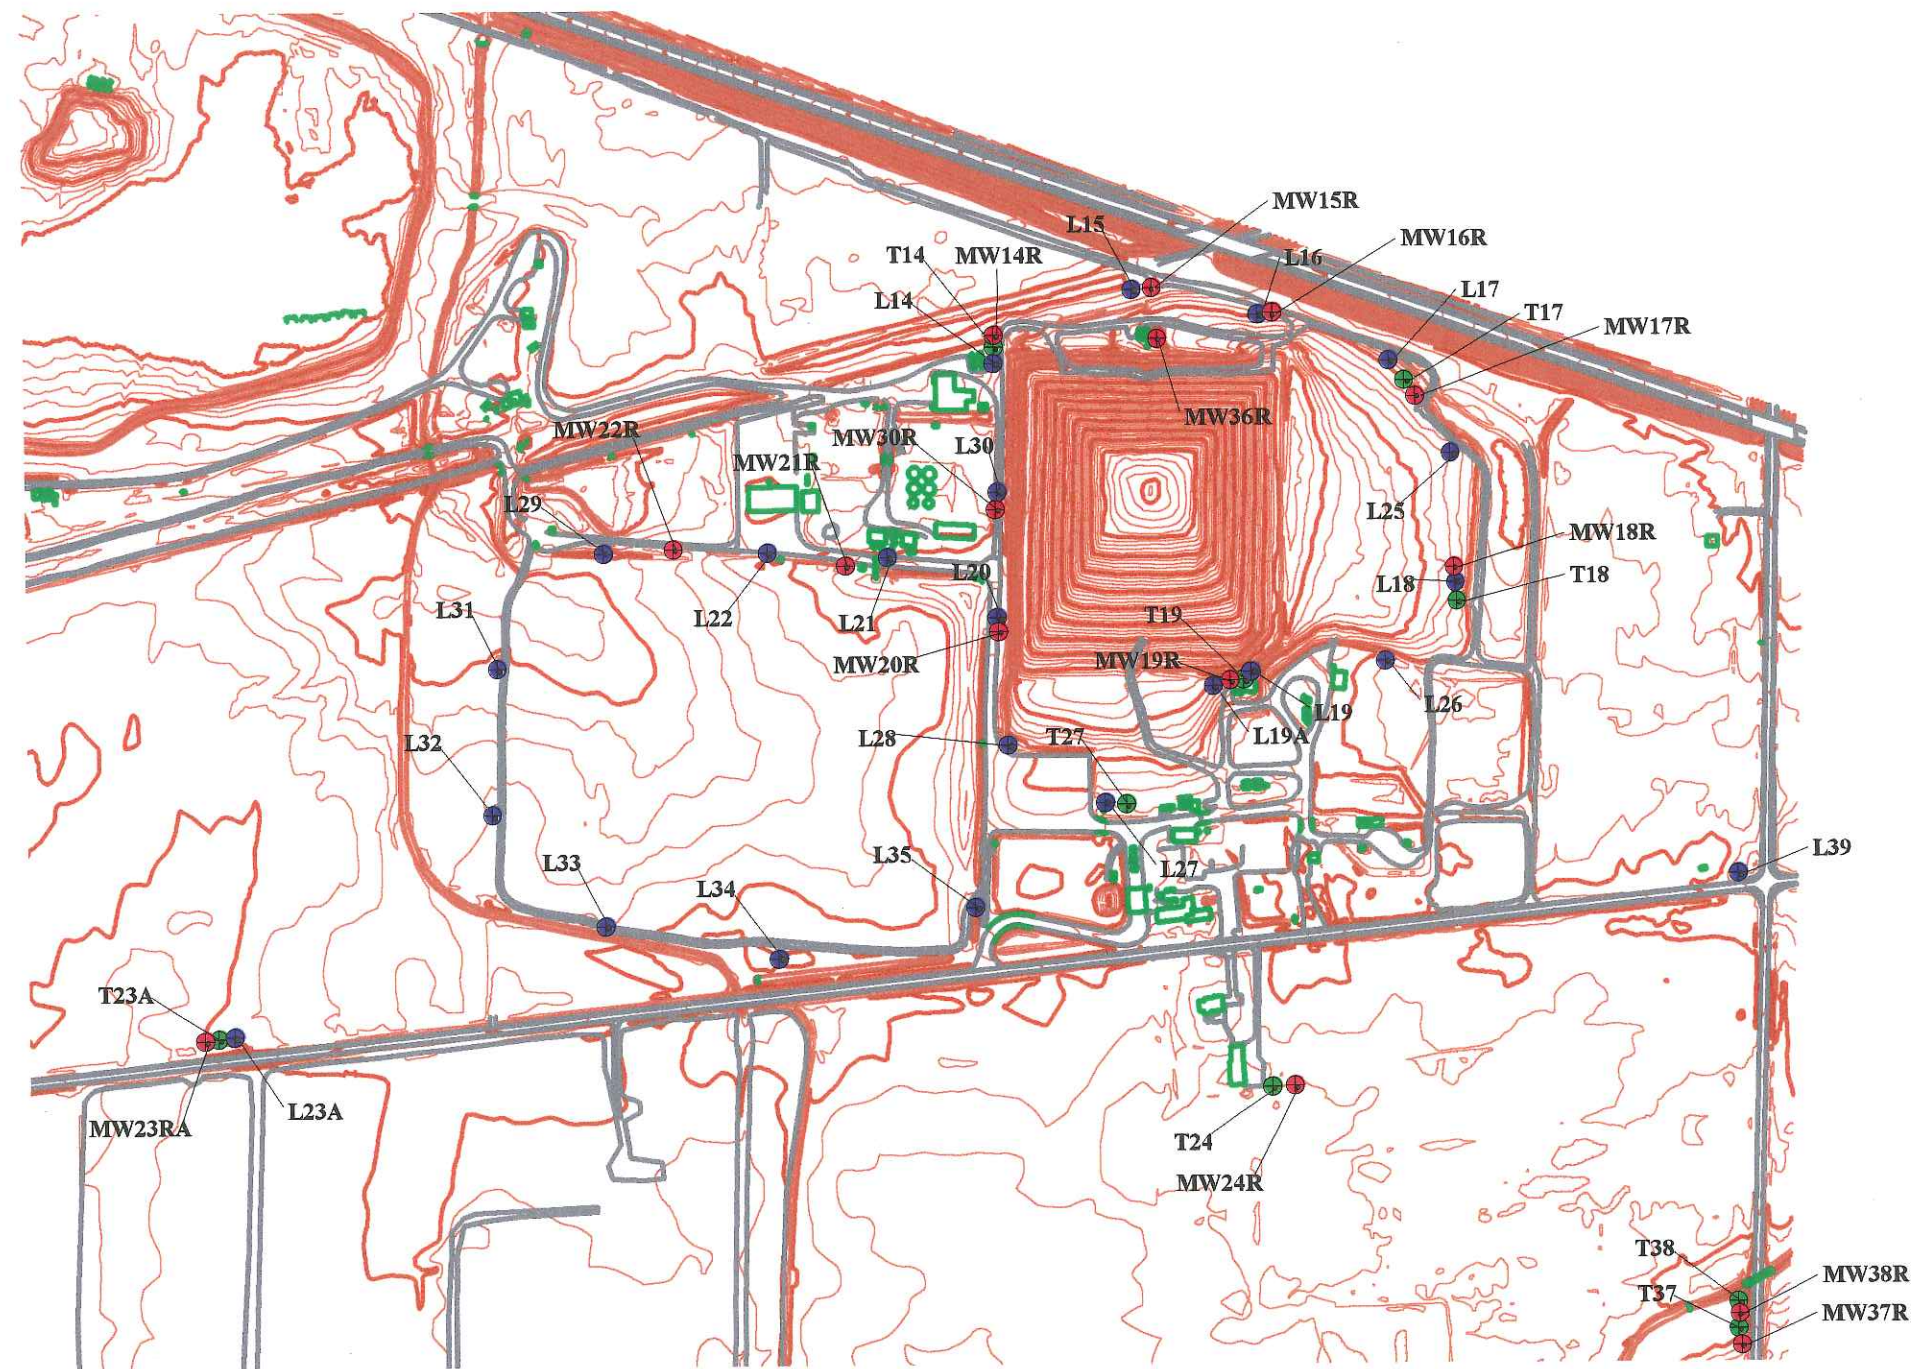
Figure 3-1
Groundwater Monitoring System Well Locations
Waste Management of Ohio - Vickery

Groundwater in the dolomite bedrock at the site flows to the north and northwest, towards Lake Erie. The bedrock exhibits a response to pumping that suggests it is a confined aquifer with fracture flow. The hydraulic conductivity of the dolomite aquifer is about 10^{-3} cm/sec. The bedrock aquifer is recharged primarily from an area about 3 miles southeast of the facility where it rises near the ground surface.

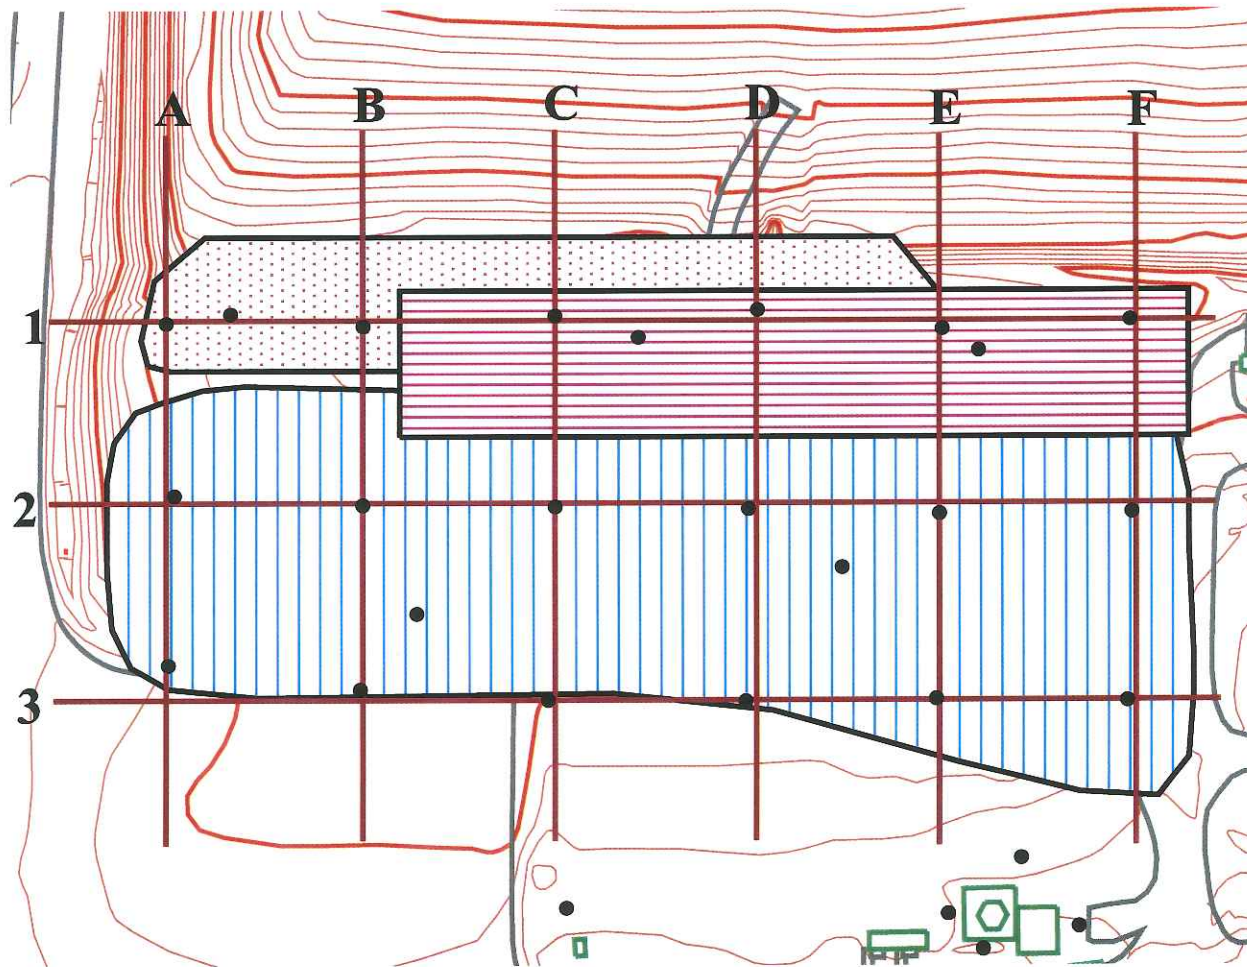
Figure 5-3.3a
Solid Waste Management Unit Group C (06, 09 & 19) Location Map
Waste Management of Ohio - Vickery

SWMU Group C consists of two former surface impoundments and a former drum storage area. Select location (SL) soil samples collected from the fixed wastes indicate the presence of waste-related parameters above the PRGs, such as benzene, chromium, and lead. As noted above, the presence of such constituents is expected within the SL samples, which were collected directly from stabilized waste materials. Additional sampling results show that evidence of contamination did not extend beneath the base of the former surface impoundments. The grid node sampling results also confirm this conclusion. The absence of these constituents in the GN samples for this SWMU group indicates they have not migrated from the stabilized waste. No PRGs were exceeded in samples from the former drum storage area.

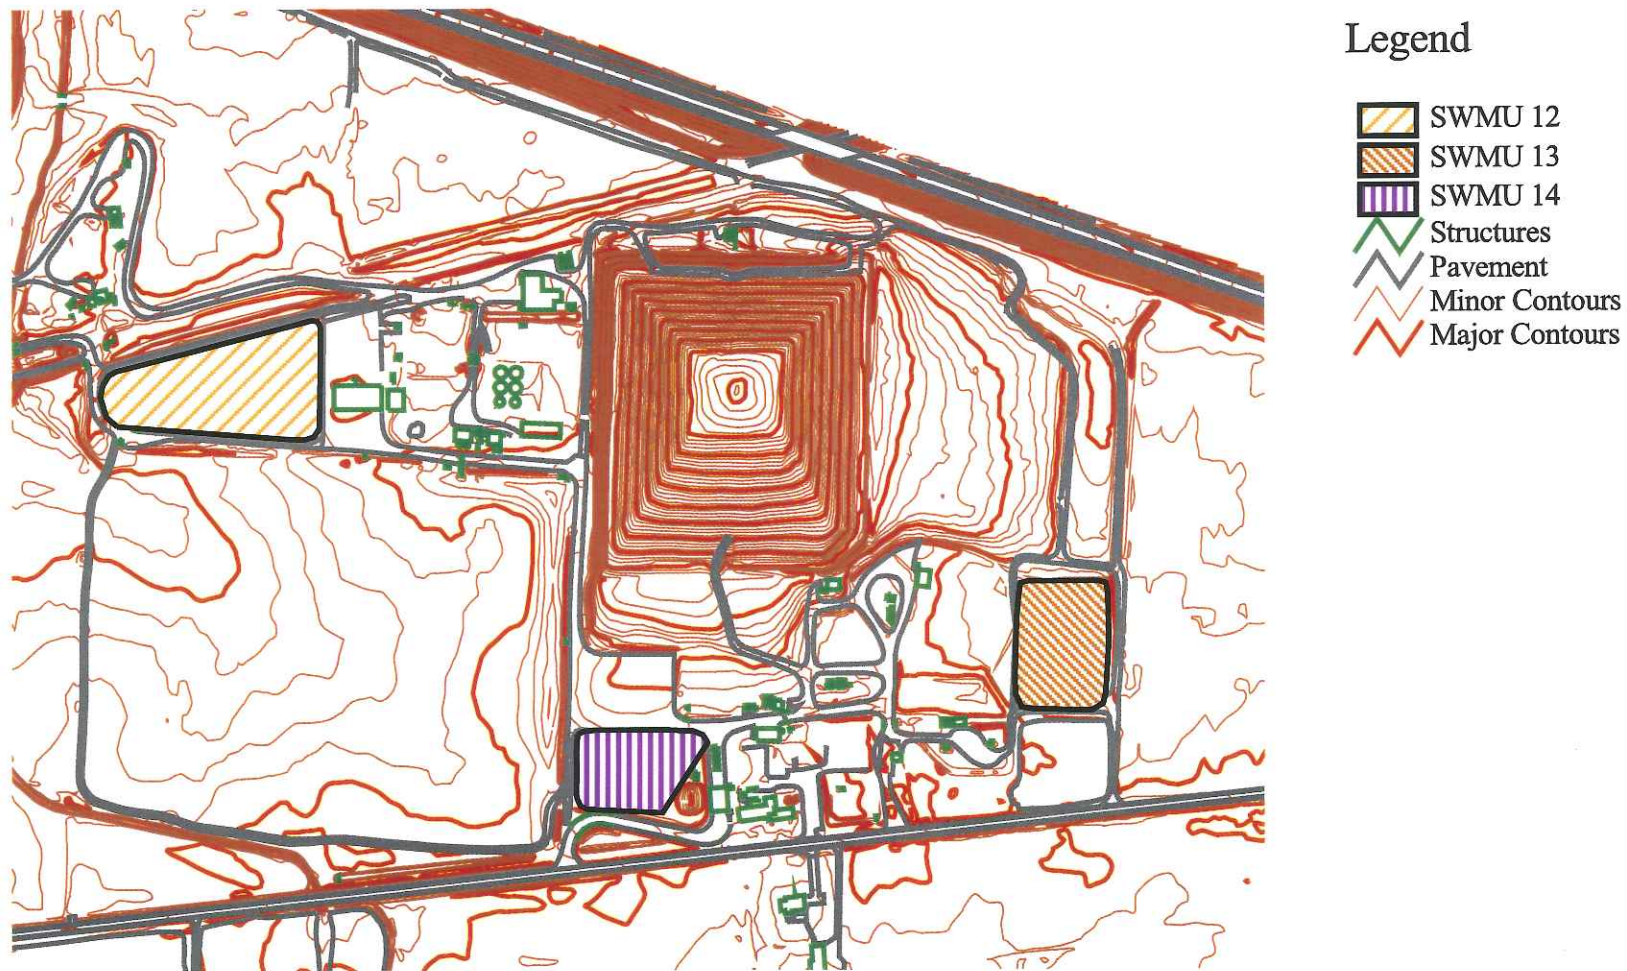
Figure 5-3.4a
Solid Waste Management Unit Group D (12, 13 & 14) Location Map
Waste Management of Ohio - Vickery

This SWMU Group consists of three former landfarm areas that were closed, backfilled with clean soils, and capped with clay. None of the soil samples collected from this SWMU Group exceeded applicable standards (the PRGs), except for benzo(a)pyrene (one sample) and arsenic. Most of the RFI soil samples contained arsenic above the PRG, but these results are interpreted to represent natural conditions and not due to impact from the facility.

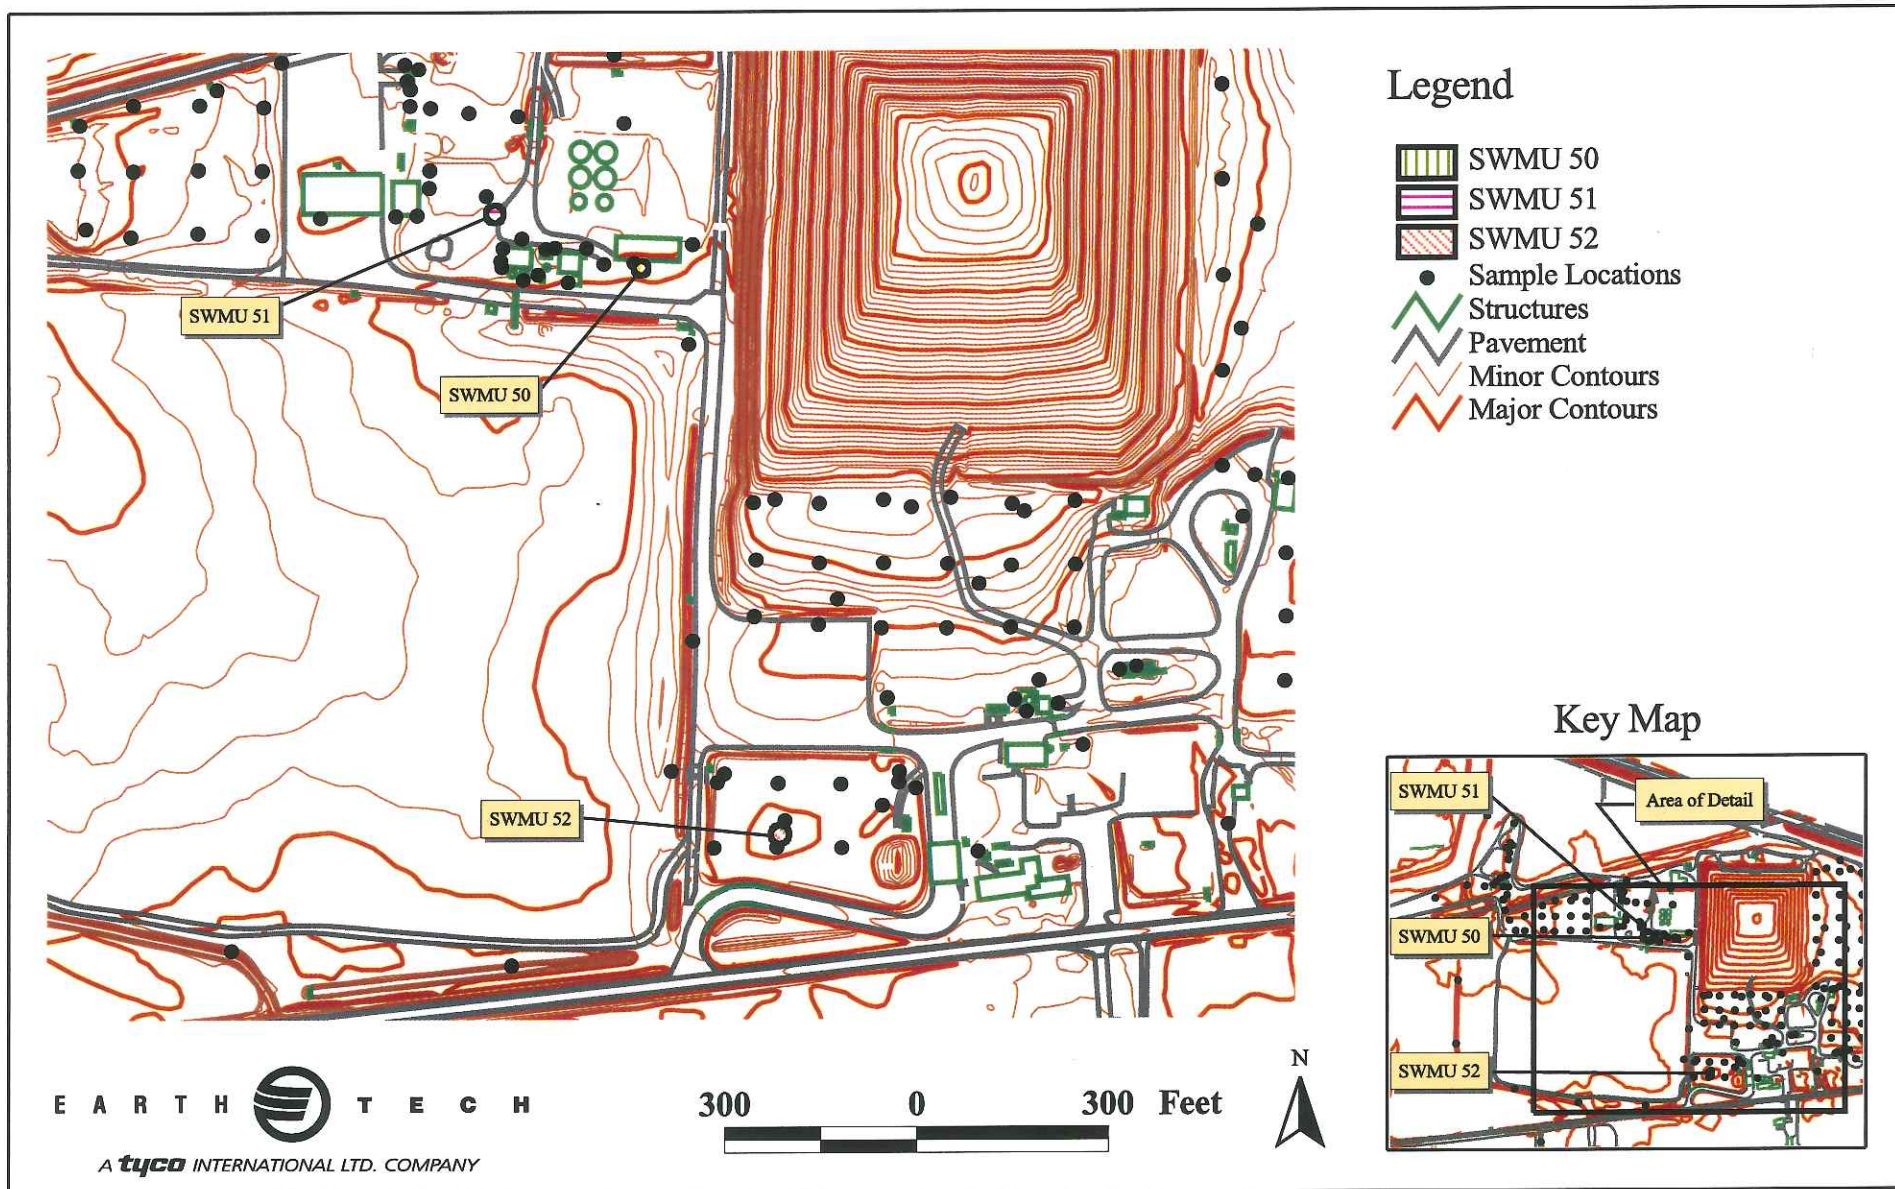
Figure 5-3.5a
Solid Waste Management Unit Group E (50, 51 & 52) Location Map
Waste Management of Ohio - Vickery

SWMU Group E consists of several former injection wells. Surficial soil samples collected around the locations of these SWMUs indicate some of the metals concentrations exceeded background but did not exceed their corresponding PRGs. The concentrations of all other constituents were also below PRGs. These results are interpreted as representing natural conditions and are not indicative of facility impact.

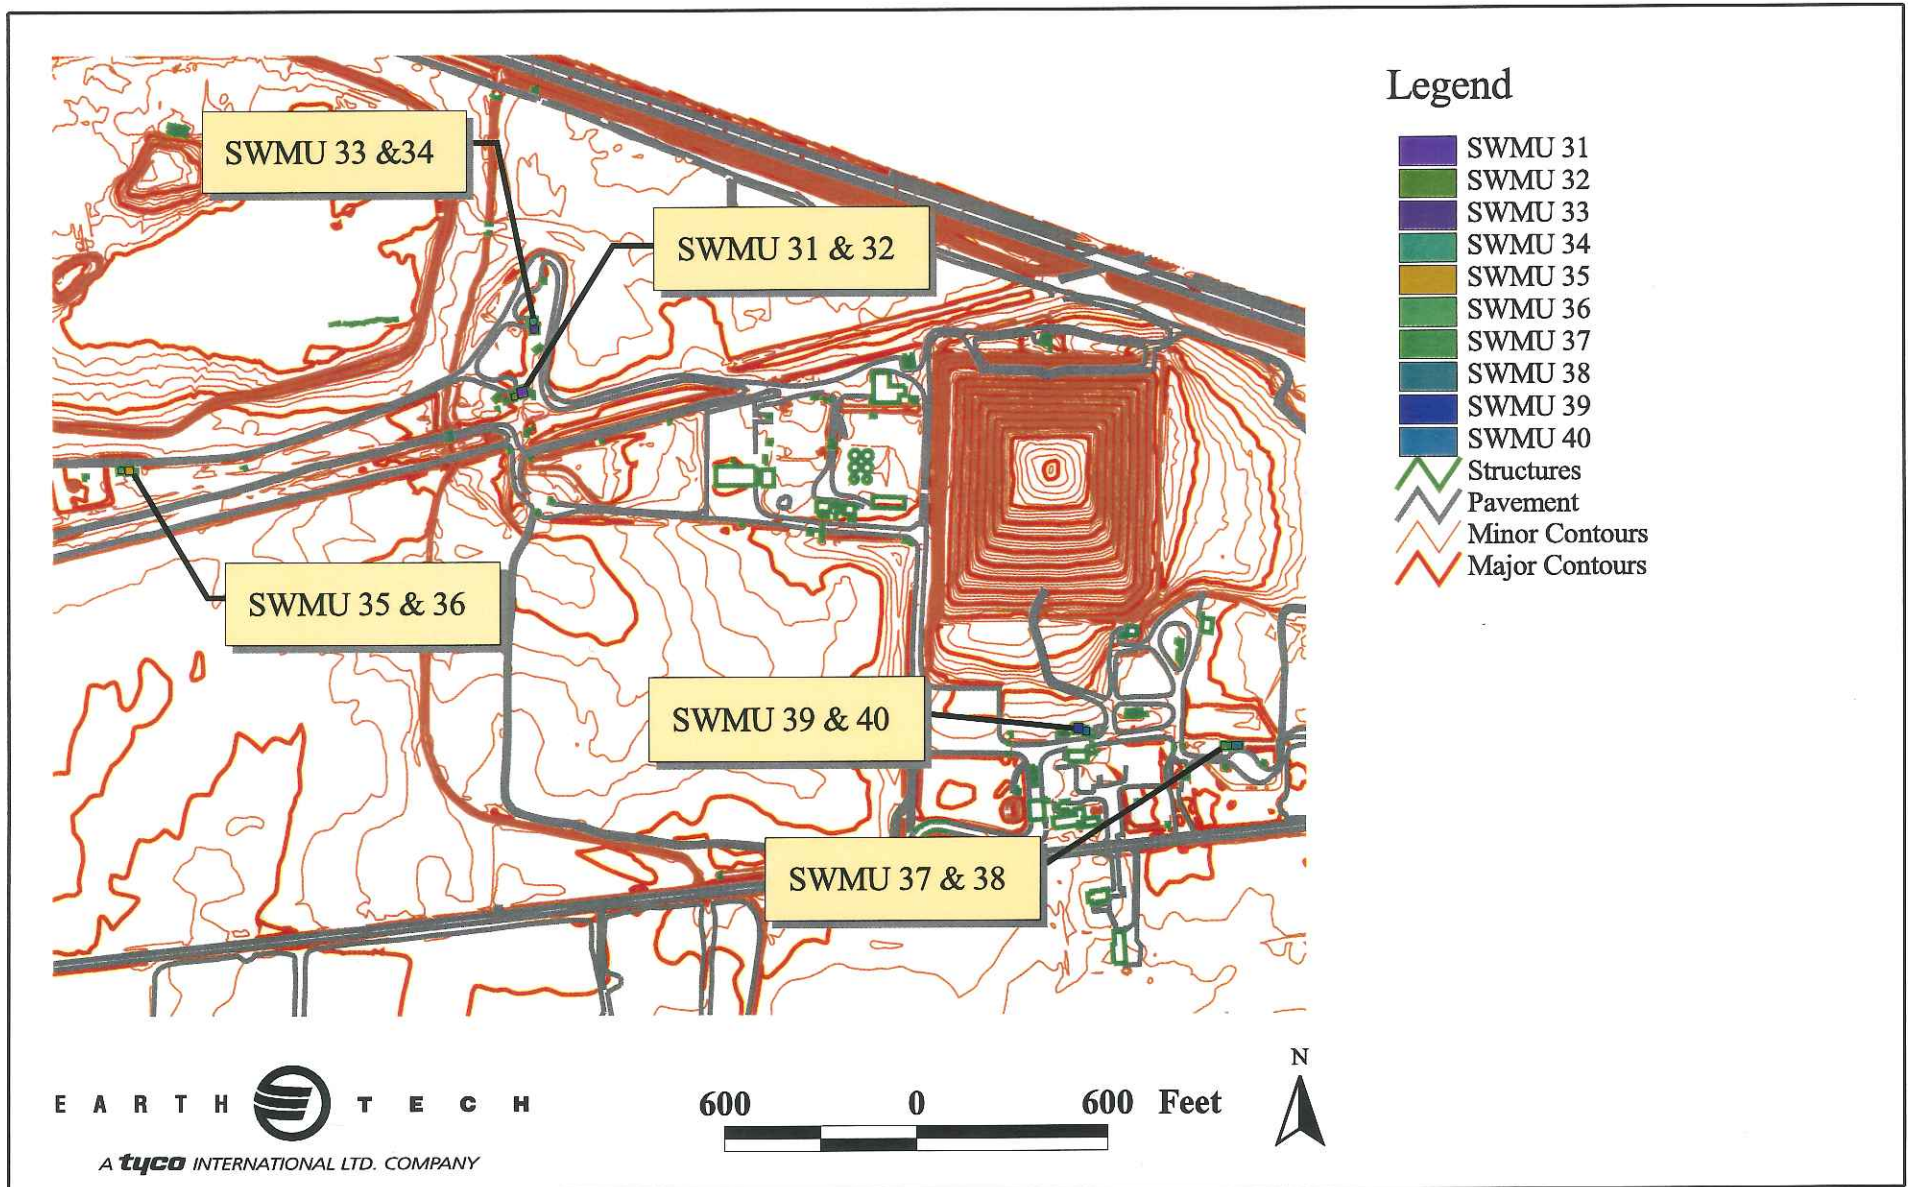
Solid Waste Management Unit Group F (31, 32, 33, 34, 35, 36, 37, 38, 39 & 40) Location Map
Waste Management of Ohio - Vickery

SWMU Group F consists of several filtered acid tanks and associated pump houses. None of the surface soil samples collected in this SWMU Group exceeded applicable standards, except arsenic and chromium. The arsenic PRG was exceeded in all of the samples, and the chromium PRG was exceeded in one sample. These conditions are interpreted as the result of natural conditions and not indicative of facility impact.

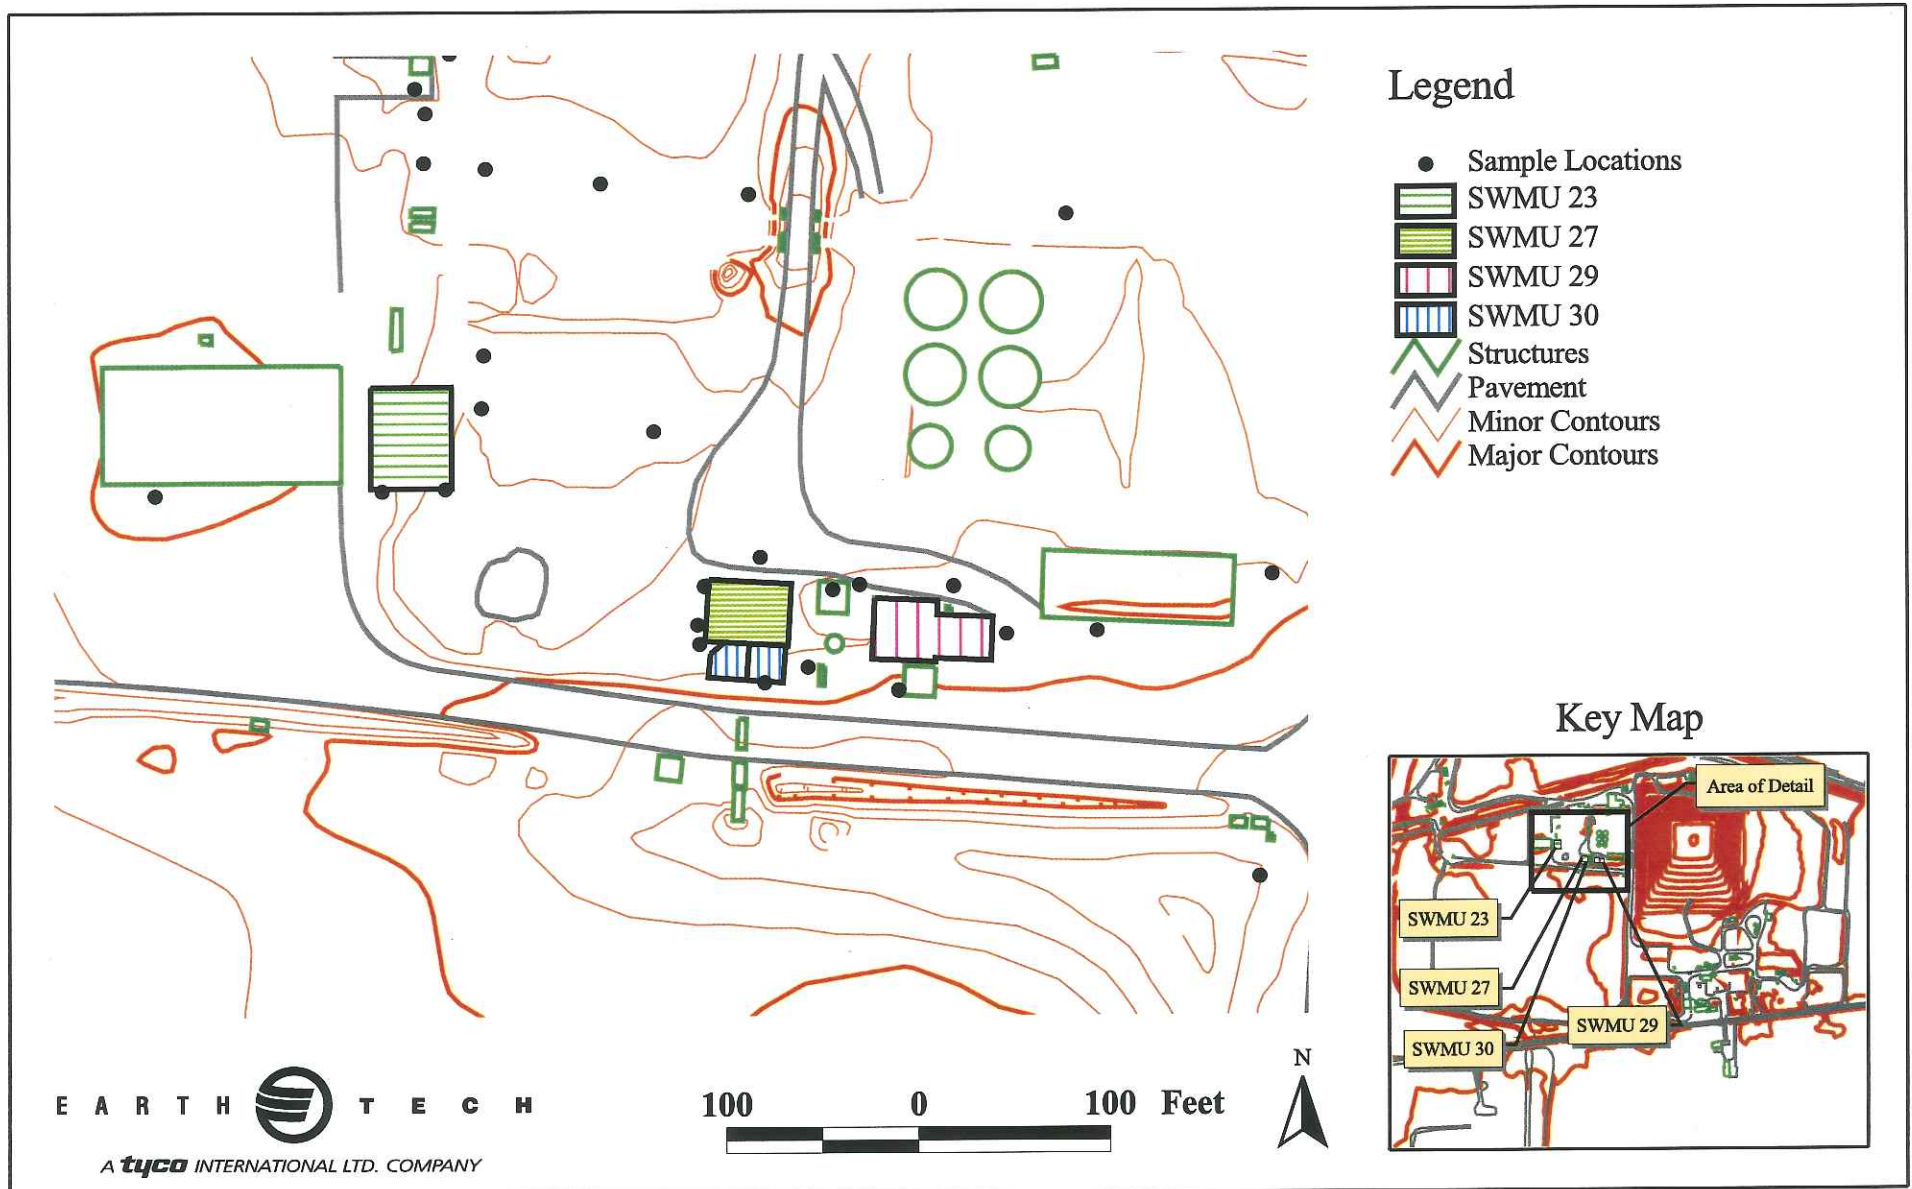
Figure 5-3.7a
Solid Waste Management Unit Group G (23, 27, 29 & 30) Location Map
Waste Management of Ohio - Vickery

SWMU Group G includes the truck unloading area, various tanks, filter presses, and pump houses. Several of these units were not sampled because there was no evidence or records of a release or potential release. Soil samples collected at the other locations did not exceed applicable standards, except for arsenic. The arsenic results are interpreted as representing natural conditions. The average background concentrations of some target metals were exceeded in several samples, but they did not exceed any corresponding PRGs. The results indicate that there have been no releases requiring further consideration.

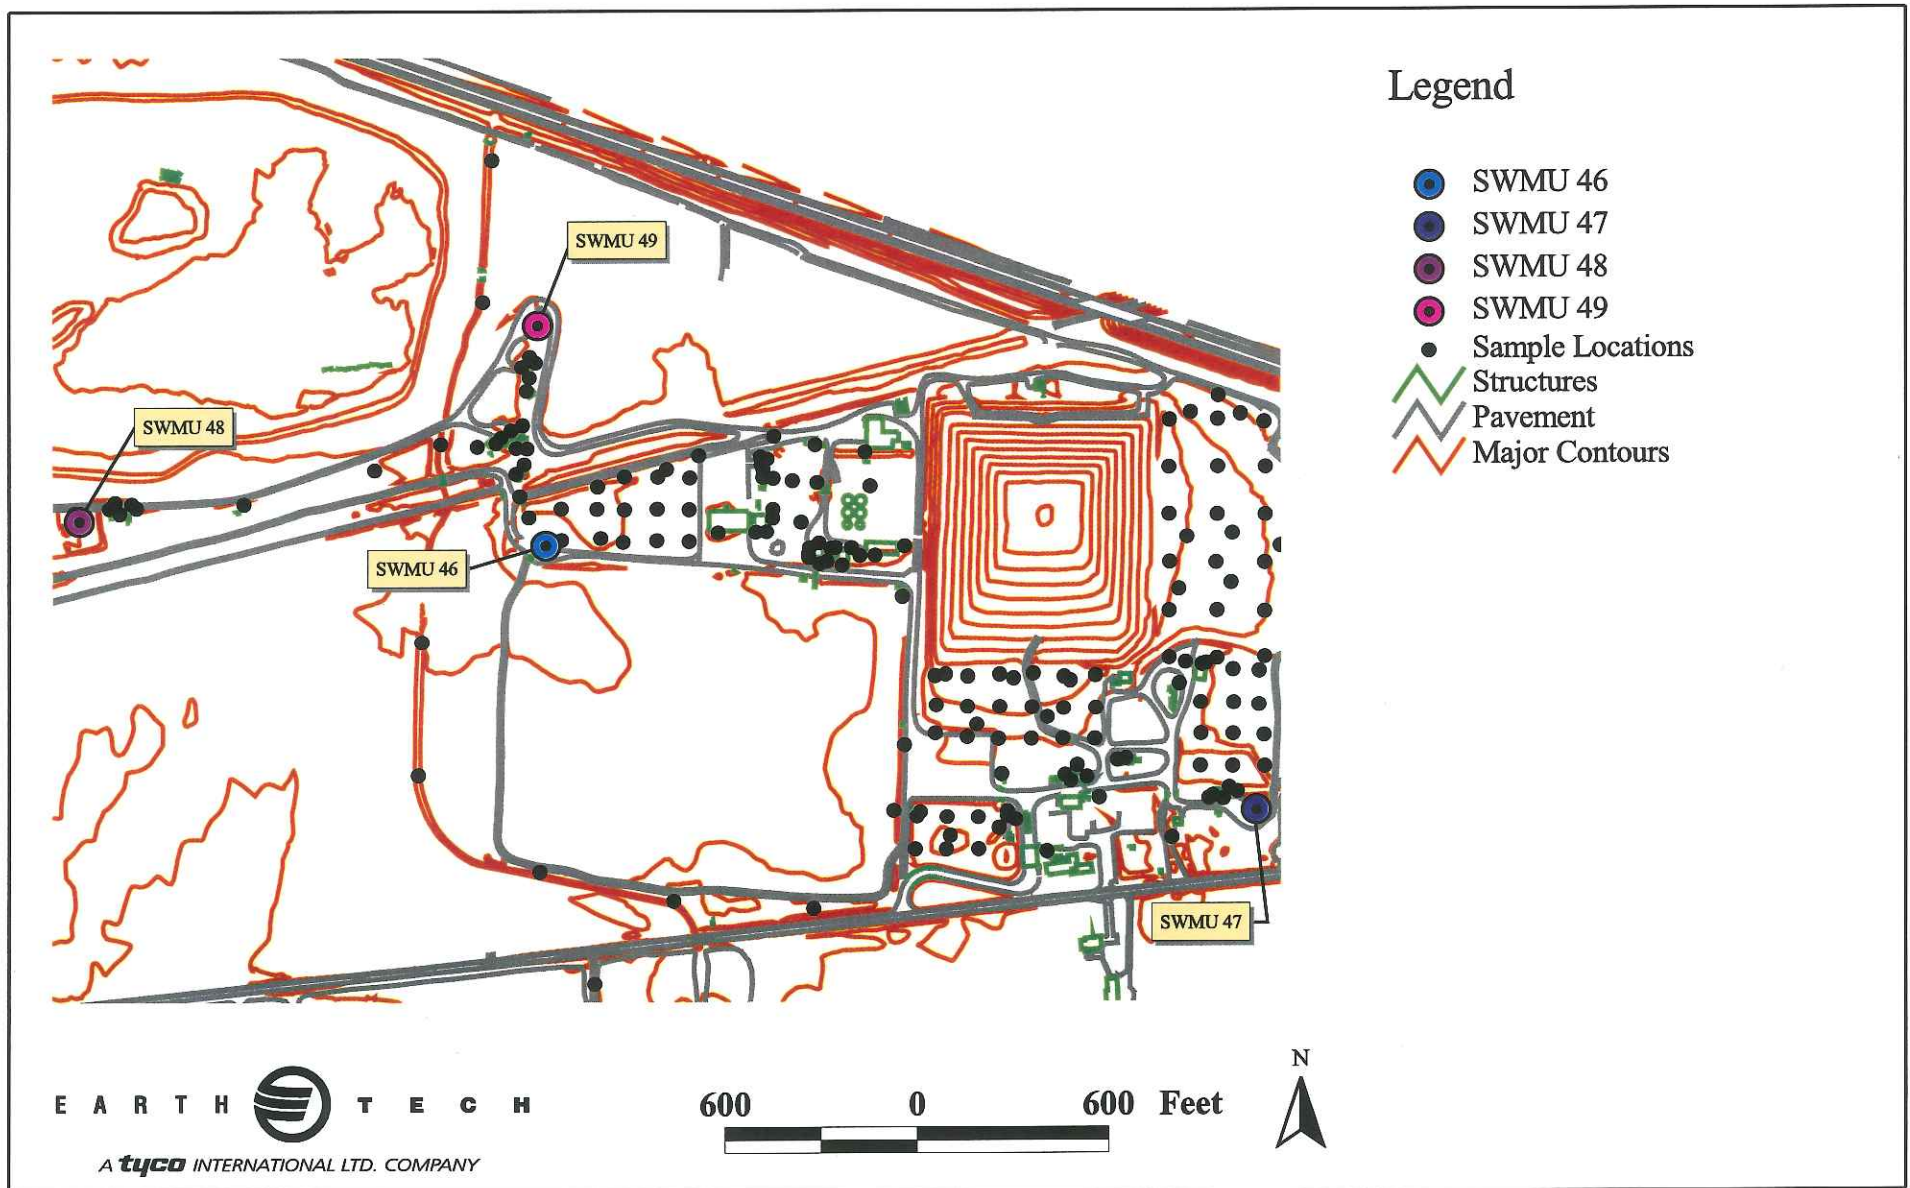
Figure 5-3.8a
Solid Waste Management Unit Group H (46, 47, 48 & 49) Location Map
Waste Management of Ohio - Vickery

SWMU Group H includes the active injection wells at the site. Surface soil samples collected around each injection well did not exceed applicable standards, except for arsenic. The arsenic PRG was exceeded in most of the samples, but only one sample exceeded the average background concentration. These results are interpreted as the result of natural conditions and not indicative of facility impact. The concentrations of some target metals exceeded the average background in several samples, but did not exceed their corresponding PRGs.

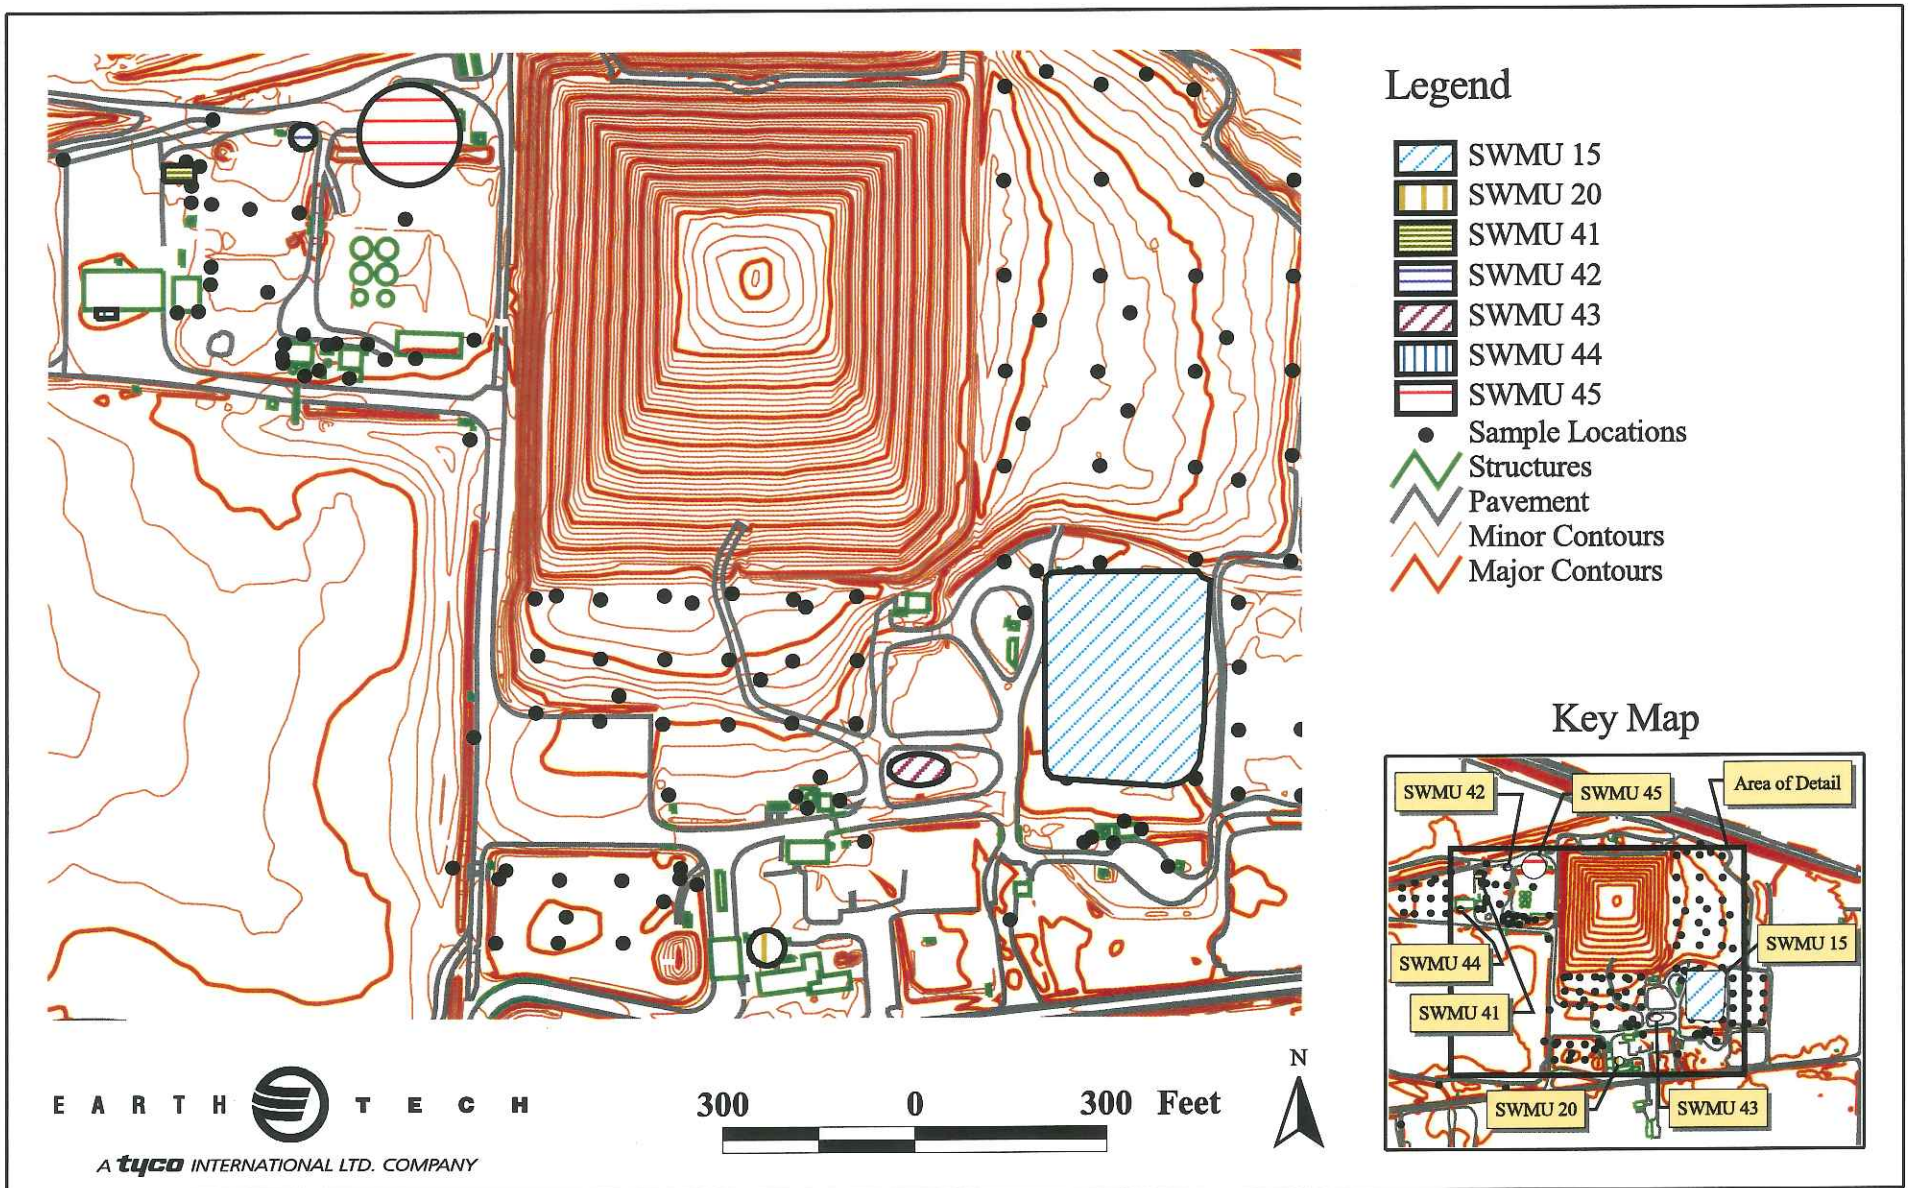
Figure 5-3.9a
Solid Waste Management Unit Group I (15, 20, 41, 42, 43, 44 & 45) Location Map
Waste Management of Ohio - Vickery

SWMU Group I consists of various tanks, an oil recovery area, and the facility's sanitary wastewater treatment facility. No sampling was conducted at the former W-Tanks or the Sluice Pit, which were clean-closed. Sampling at the other locations showed that only one sample in the oil recovery area exceeded a PRG (for chromium). This indicates that the remediation conducted in this area was sufficient, as no PCB or SVOC exceedences were noted. At the lab waste tank, there was no apparent indication of a contaminant release. No potential waste constituents were observed above applicable standards at the PCB storage area, except for arsenic and benzo(a)pyrene. These conditions do not indicate significant impact at this concentration. No impacts from the sanitary wastewater treatment facility or the Truck Unloading Facility and Maintenance Building Sewage Holding Tanks were noted.
